WRDC-TR-89-4055

COMPENDIUM OF FRACTOGRAPHIC DATA FOR COMPOSITE  
MATERIALS

INTERIM REPORT  
Covering 9-22-86 through 10-31-88

C. Hua  
M. Yamashita  
Boeing Advanced Systems  
P.O. Box 3707  
Seattle, WA 98124

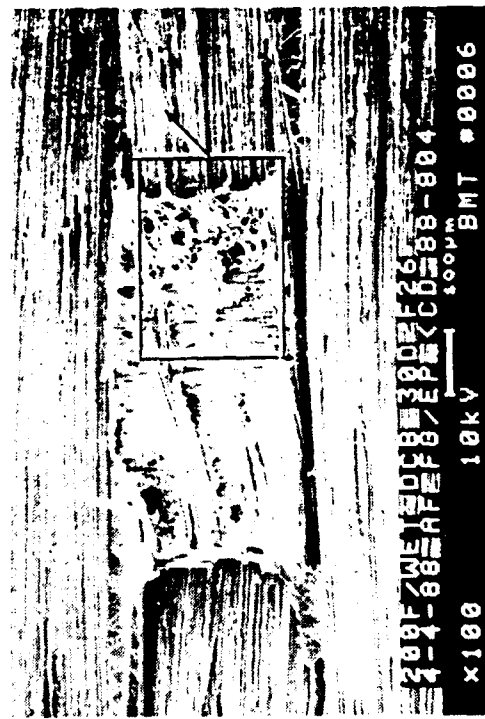
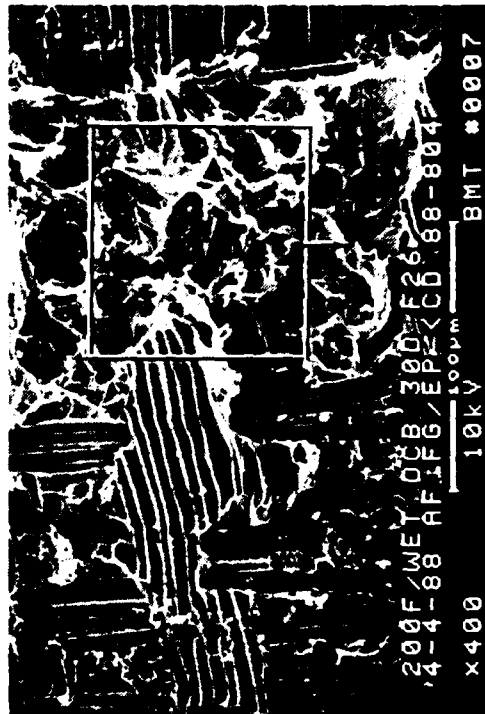
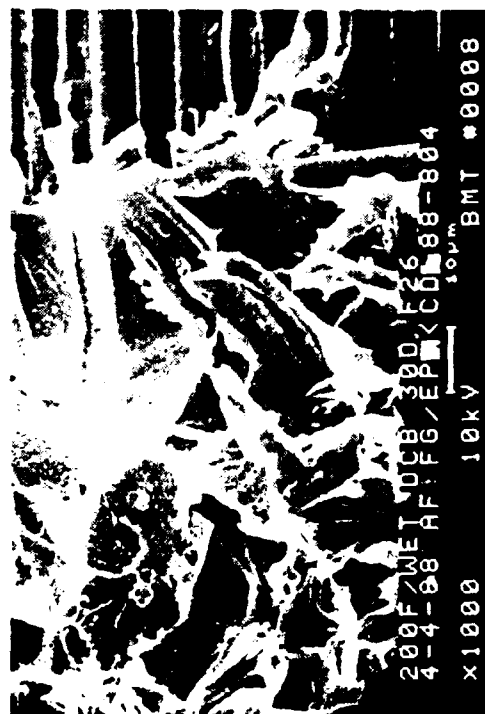
Figure 4.4-134. SEM Fractographs of 200F Wet, Interlaminar Mode I Tension Fracture in Fiberglass/Epoxy

evidenced by specimen end deflection and incomplete fracture into two halves. The resistance of the 200°F/wet specimen to fracture may be due to the increased toughness of the resin matrix due to moisture exposure.

Figure 4.4-134 shows the SEM fractographs of the interlaminar Mode I tension, 200°F/wet specimen. Fiber/matrix adhesion was poor as evidenced by the smoothness of the fiber surface. Unlike the RT/dry specimen, this specimen did not exhibit well-defined rivermarks indicating the crack direction. Instead, the surface showed taffy-pull hackles commonly seen in ductile resin matrices such as thermoplastics.

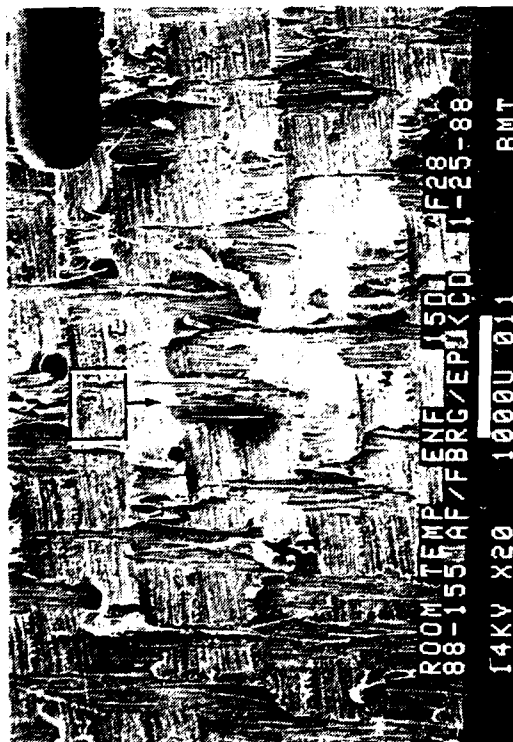
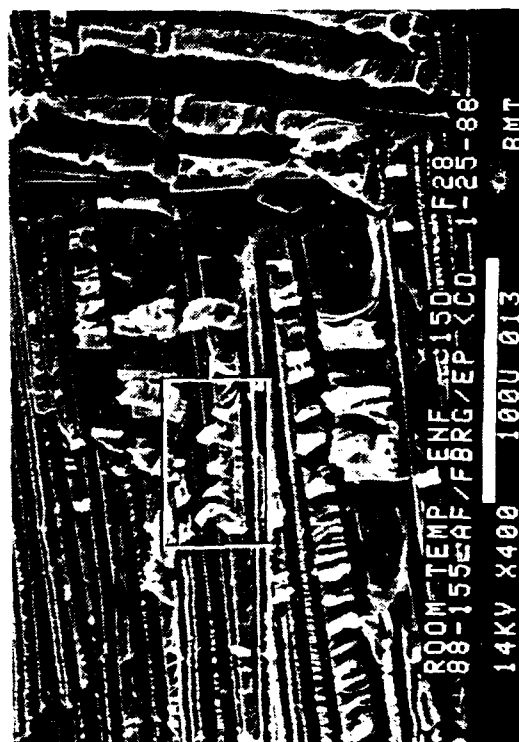
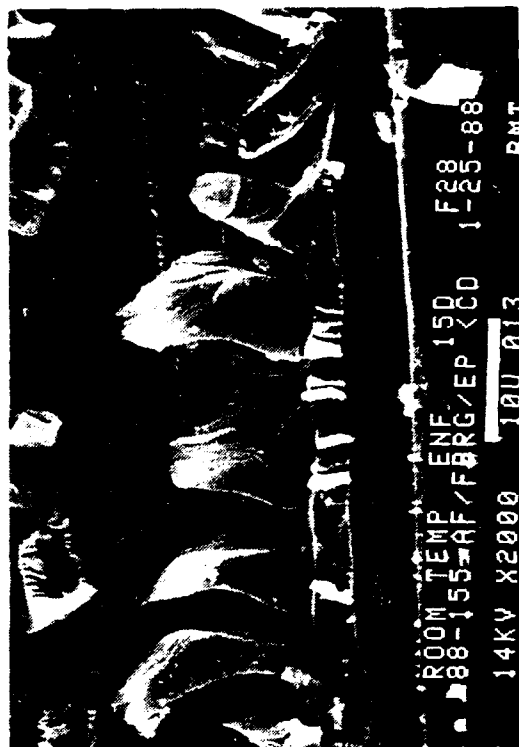
Figure 4.4-135. SEM Fractographs of Room Temperature, Interlaminar Mode II Shear Fracture in Fiberglass/Epoxy

SEM analysis (Fig. 4.4-135) revealed a rough fracture surface consisting of large numbers of hackles, which appear similar to the platelets seen in Mode II shear fractures of carbon fiber reinforced epoxies. There was poor adhesion of the fiber/matrix interface at some locations, is due to the low inherent interfacial shear strength.

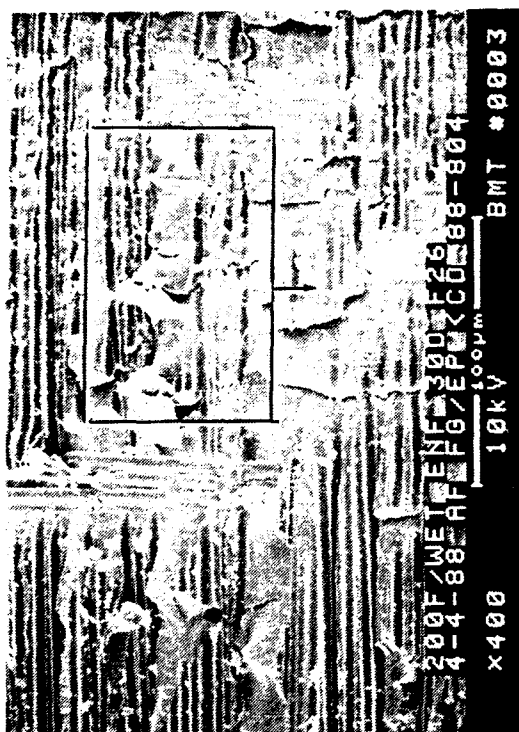
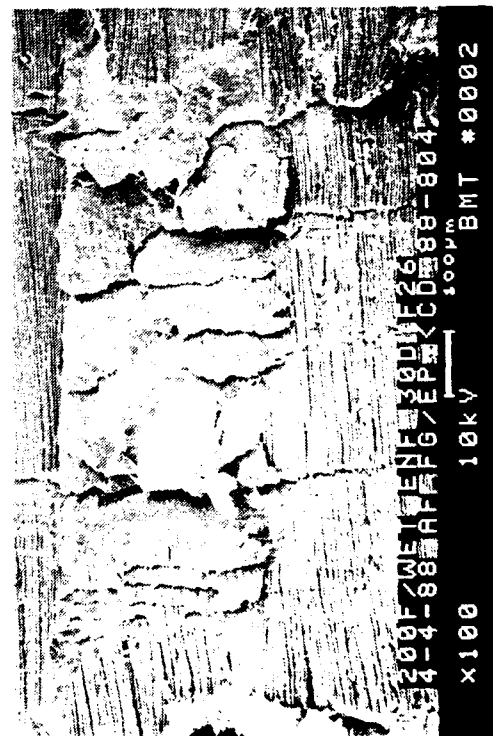
Figure 4.4-136. SEM Fractographs of 200 F/Wet, Interlaminar Mode II Shear Fracture in Fiberglass/Epoxy

Figure 4.4-136 shows the SEM fractograph of the fracture surface which appeared rough and showed hackles as observed in the RT/dry specimen. These hackles were much larger, but fewer in number than those seen in the RT specimens.

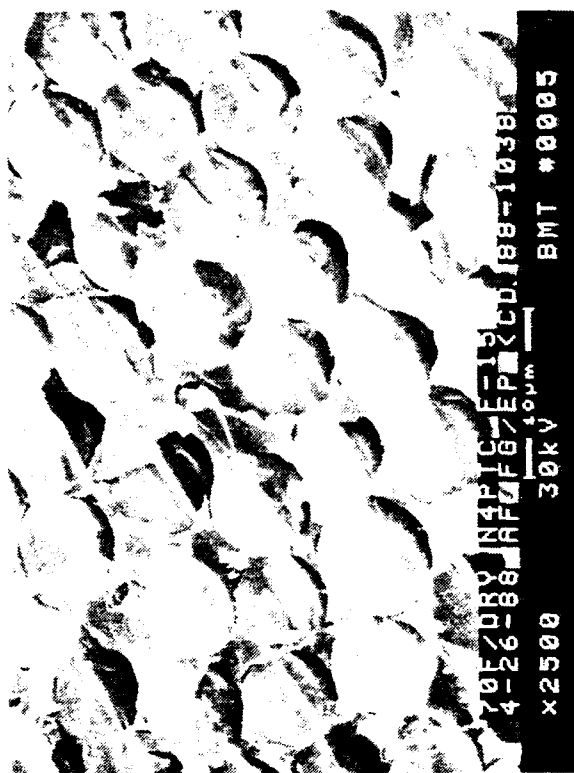
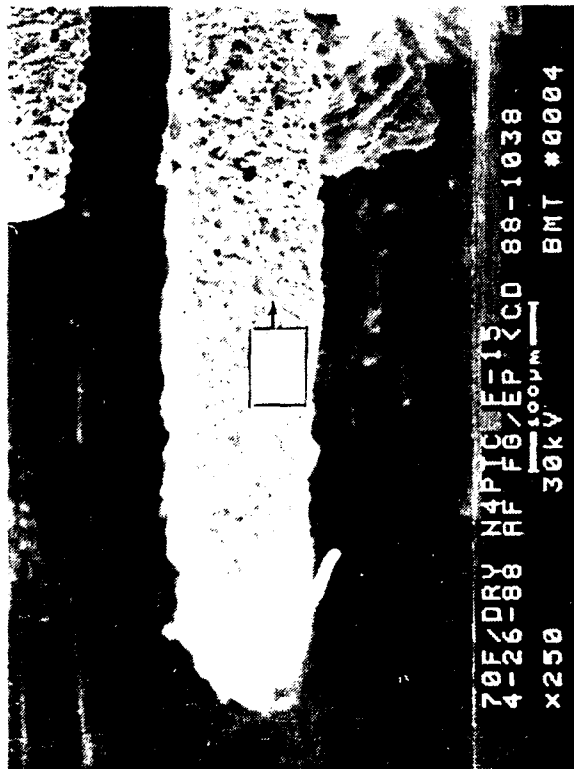
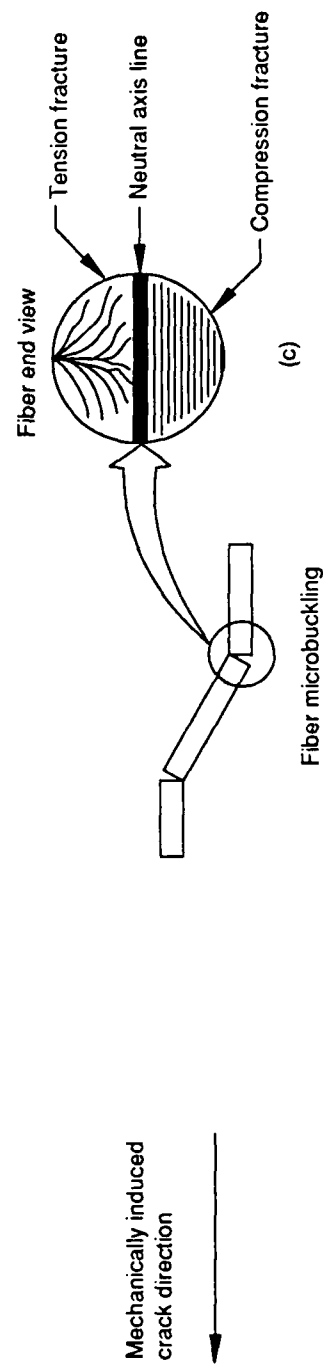
Figure 4.4-138. SEM Fractographs and Diagram of 70 F/Dry, Translaminal Compression Fracture in Fiberglass/Epoxy; Shown at 0 Degree Tilt

Translaminar Compression, RT/Dry. Visual and optical observations revealed a surface with uniform protruding fibers. The fiber/matrix interface showed good adhesion. Figures 4.4-138 and 4.4-139 show the SEM fractographs. A neutral axis line dividing the tension and compression regions on the fiber ends was observed.

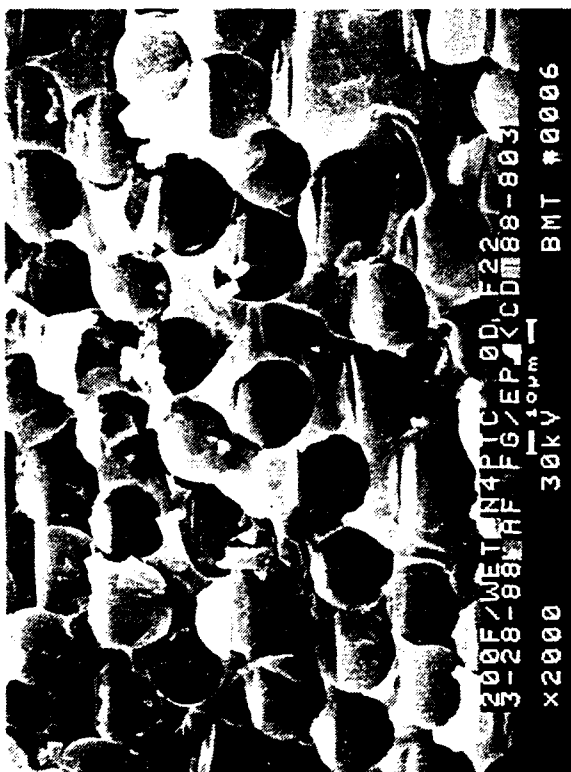
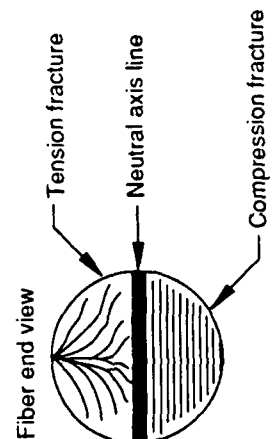
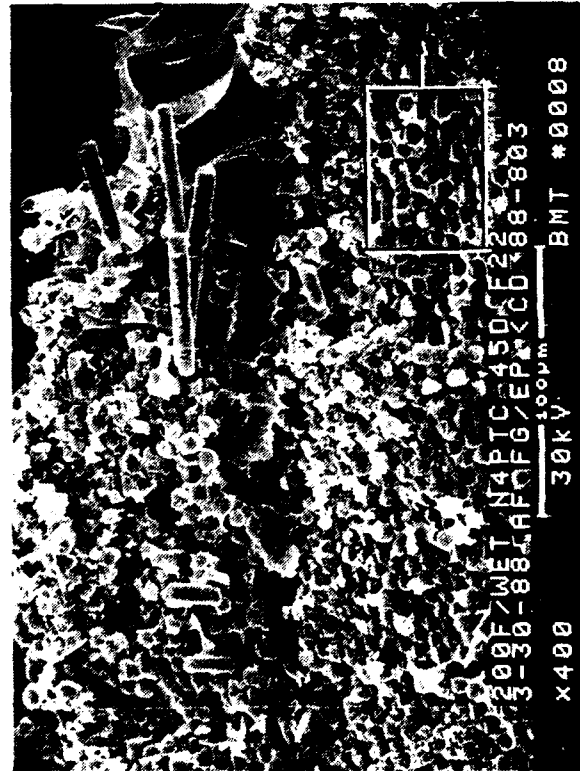
Figure 4.4-141. SEM Fractographs of 200 F/Wet, Translamellar Compression Fracture in Fiberglass/Epoxy; Higher Magnification

Translaminar Compression, 200°F/Wet. Optical observation of the 200°F/wet specimen revealed a fracture surface like that typically seen in RT/dry translaminar compression specimens. The compression damage occurred in the region just outside of the notch. The typical fracture of a translaminar compression specimen exhibited a flat surface with "chop" marks on the fiber ends (Fig. 4.4-140). Compressively fractured fiber ends show two distinct regions separated by a neutral axis line. This line does not represent any kind of crack direction (Fig. 4.4-141).

Fiber microbuckling

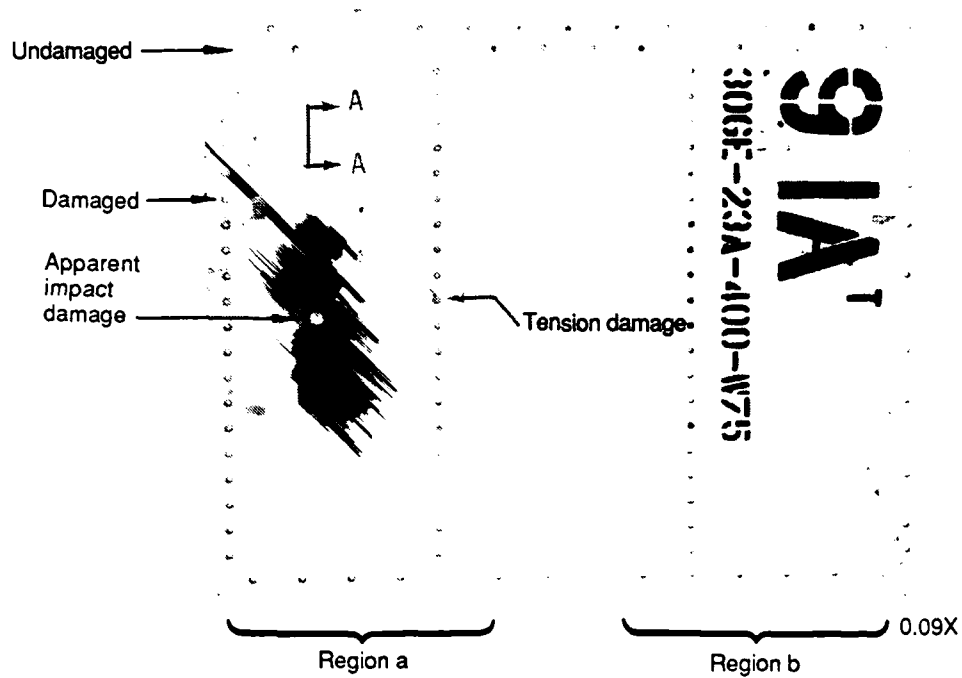
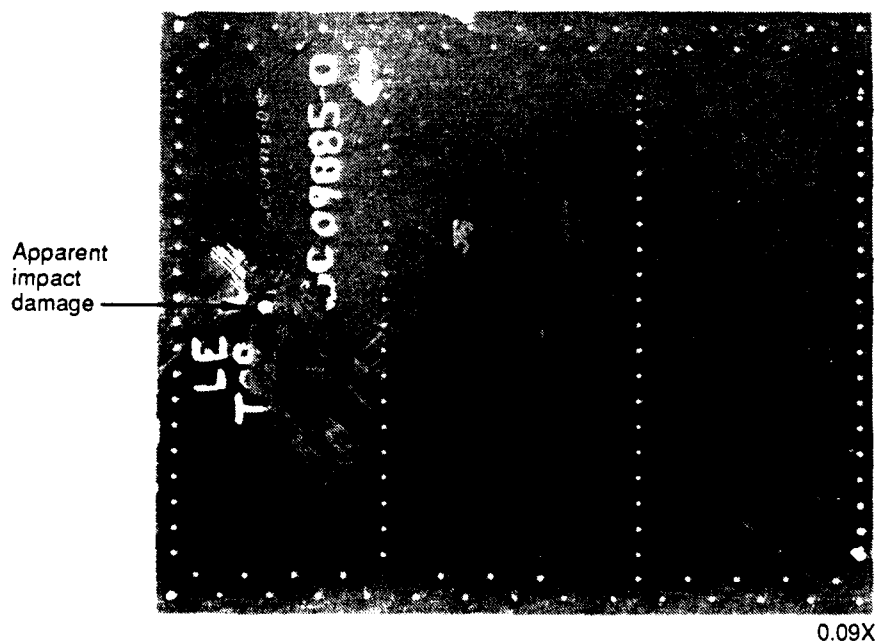
Figure 7.4-1. Photomicrographs of the Component As Received

Figure 7.4-1 shows the fractured test panel in its as-received condition. The rectangular panel, with a dimension of 43 by 36 inches, appeared to have been fastened to one or more fixed structures during testing. Due to limited background information, the emphasis was placed on the visual examination. At the time of the part's receipt, it was speculated that the part had been fractured via impact loading. This speculation was made due to the appearance of the damage which was typical of that observed in impact loaded structures.

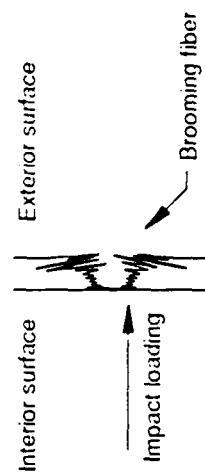
Figure 7.4-2. Apparent Impact Damage

**Visual Examination.** As shown in Figure 7.4-2, the damage appeared to have been caused by an object penetrating through the panel from the interior surface (Fig. 7.4-2a), as evidenced by the brooming fibers on the exterior surface (Fig. 7.4-2b). These damage features are commonly observed in an impacted specimen.

Note the depression  
at the impact site  
which indicates the  
direction of the  
penetration

Brooming fiber

(b) Damage on the exterior surface

(a) Damage on the interior surface

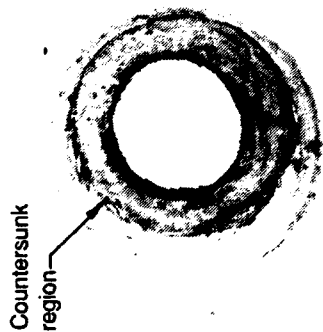
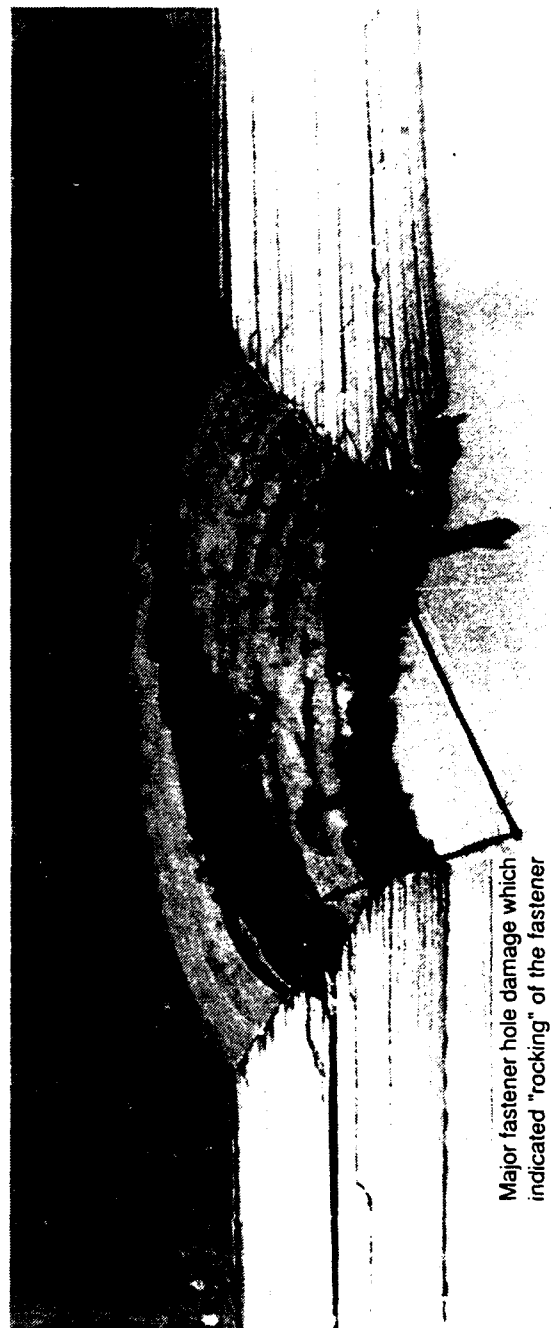
Figure 7.4-3. Damage in Fastener Hole Loaded Under Shear

In conjunction with stress analysis, visual examination was performed using fastener hole damage as evidence to determine the loading condition experienced by the panel during the test. The key evidence was the depth and elongation of the hole. In general, hole elongation indicates shear-type loading in which the head and the shank of the fastener tilt at an angle to the hole. Figure 7.4-3 illustrates the damage of a typical shear loaded fastener hole. The damage seen in the countersunk region of the fastener

hole was created by the fastener head which dug into the laminate due to the test load. In contrast, tension loaded fastener holes did not show any sign of elongation, retaining their circular shape (Fig. 7.4-4). The fastener head dug beyond the countersunk region causing severe delamination near the inner edge of the hole. Figure 7.4-5 shows the mapping of the fastener hole damage. From the mapping, it was determined that Region A of the panel was loaded under tension and shear. However, Region B seemed to have been securely fastened to a fixed structure as evidenced by the lack of fastener hole damage in that portion of the panel.

The fastener hole damage observed in certain locations on the test panel indicated that some of fasteners were not designed for the particular application. The fasteners on the end of Region A experienced a substantial amount of shear loading compared to the rest of the panel. The recommendation would be to examine the hole damage and make appropriate changes in the fasteners (i.e., change to shear or tension) to accommodate the load conditions experienced during the initial testing. Due to the fact that the mechanical test was unknown, recommendation for design improvement is difficult.

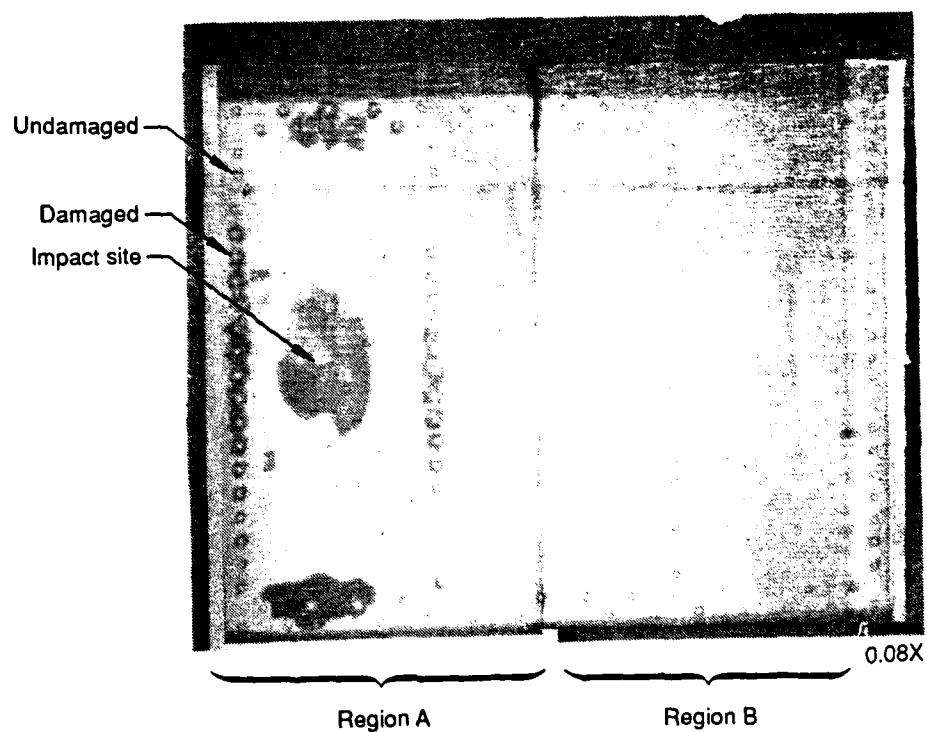
Figure 7.4-8. Through Transmission Ultrasonic (TTU) Scan of Component

**Non-Destructive Evaluation.** To determine the extent of the damage, through-transmission ultrasonic inspection (C-scan) was performed. The dark-shaded regions in the vicinity of the fastener holes and at the apparent impact site indicate the damaged region. These regions are shaded due to higher attenuation from the anomalous regions. Most of the damage occurred on one half of the panel, Region A, as shown in Figure 7.4-8.

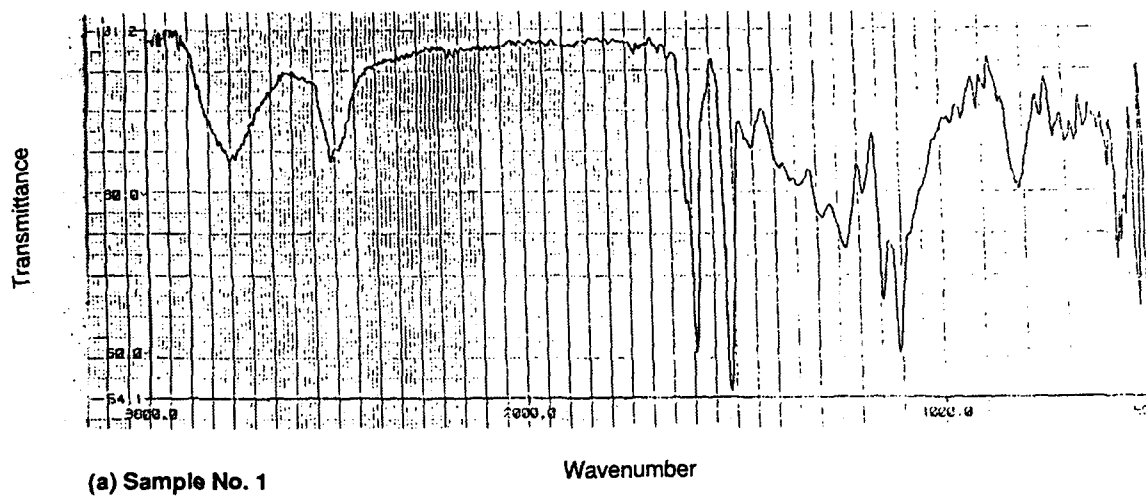
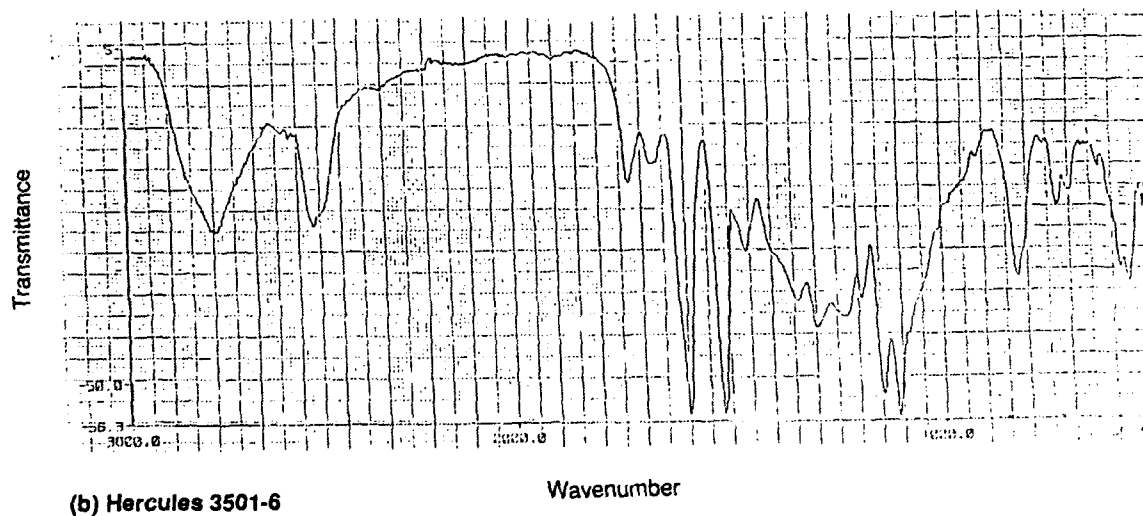
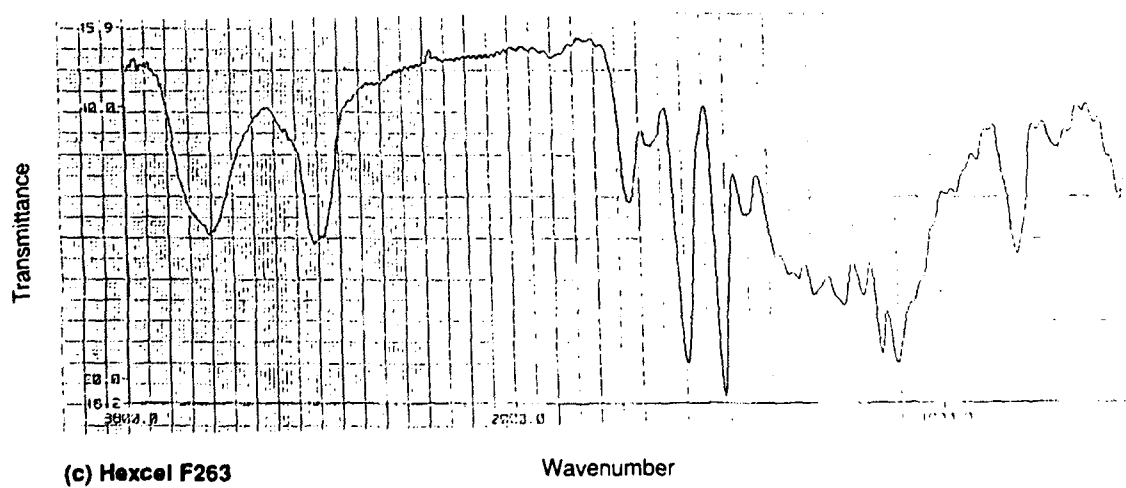
Figure 7.4-9. Infrared Spectroscopy Results

A Fourier transform infrared (IR) spectrometer was used to determine the resin used to fabricate the component. Two samples from the panel were analyzed. Figure 7.4-9 shows the infrared (IR) spectra obtained from the test sample. The general resin type was determined to be a 350°F cure conventional epoxy system by the method of fingerprinting using the limited in-house database of IR spectrum. Figures 7.4-9b and c show the IR spectrum of Hercules 3501-6 and Hexcel F263 prepreg materials respectively; these spectra were used for fingerprinting those obtained from the sample.

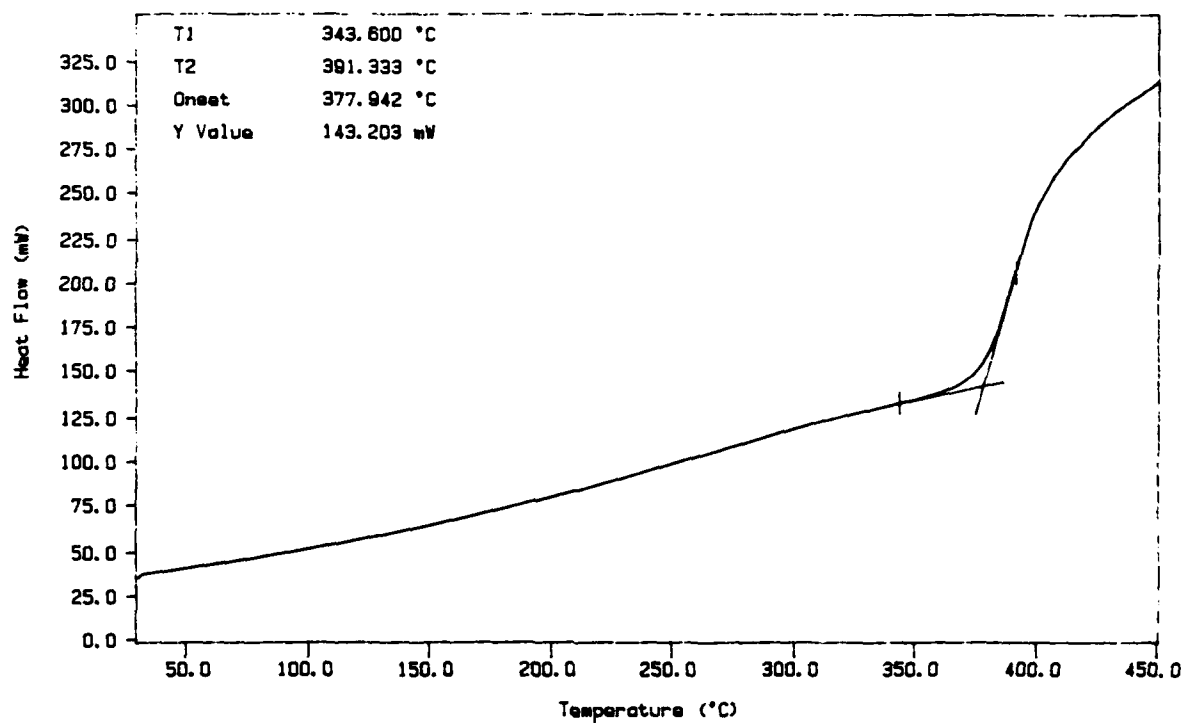
Figure 7.4-10. DSC Thermogram

Differential scanning calorimetry (DSC) showed no exothermic peaks, indicating that the material was fully cured (Fig. 7.4-10). A decomposition at 378°C was also observed. Thermomechanical analysis (TMA) showed the average glass transition temperature (T<sub>g</sub>) to be 210°C (410°F, Fig. 7.4-11). Thermogravimetric analysis (TGA) indicated the composite decomposed at approximately 357°C (675°F, Fig. 7.4-12).

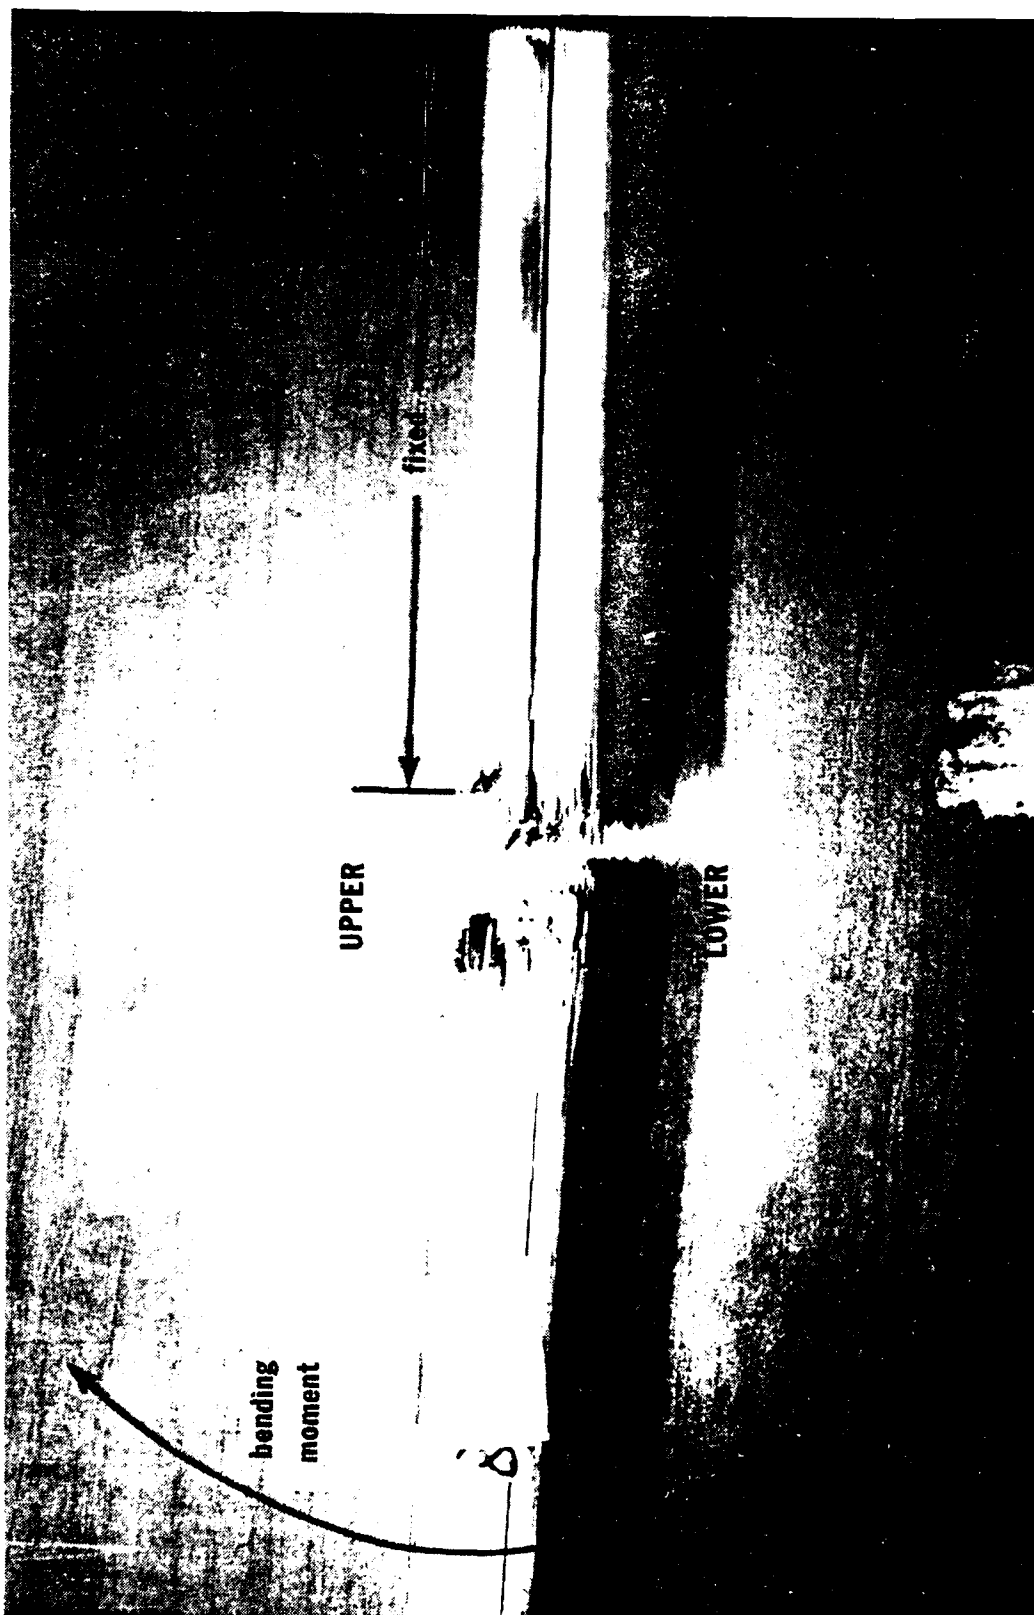
Side view—delaminations

**Figure 7.4-20. Macrophotographs of Side of Strut Showing Delaminations.** The figure shows the apparent loading condition which led to failure. The bending moment was greatest at the edge of the fixed portion of the strut, the failure location. As anticipated from this loading condition, the upper surface failed in compression and the lower surface failed in tension.

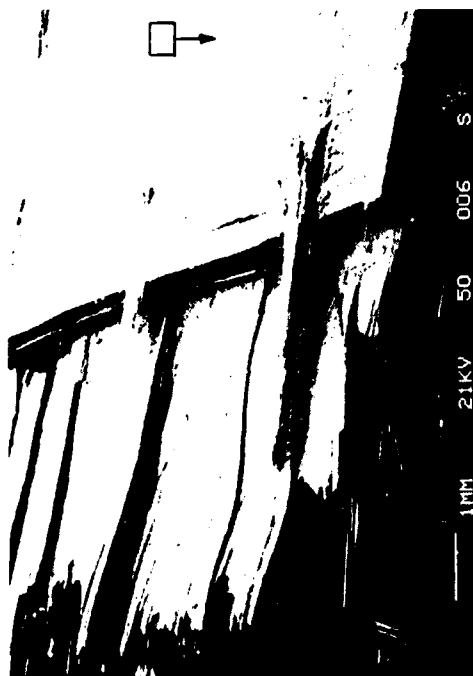
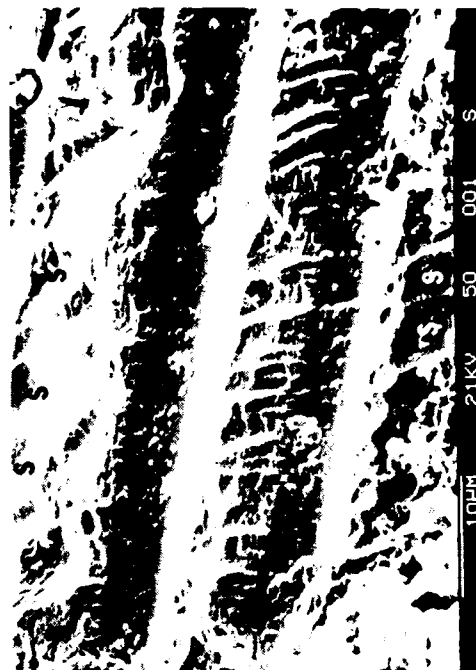
Delamination—50 degree tilt 11X

Figure 7.4-24. SEM Fractographs of Delamination at the Translaminal Fracture Surface of the Small Piece. Scallops indicate shear fracture. The orientation of these scallops indicates progation of the delamination axially along the strut.

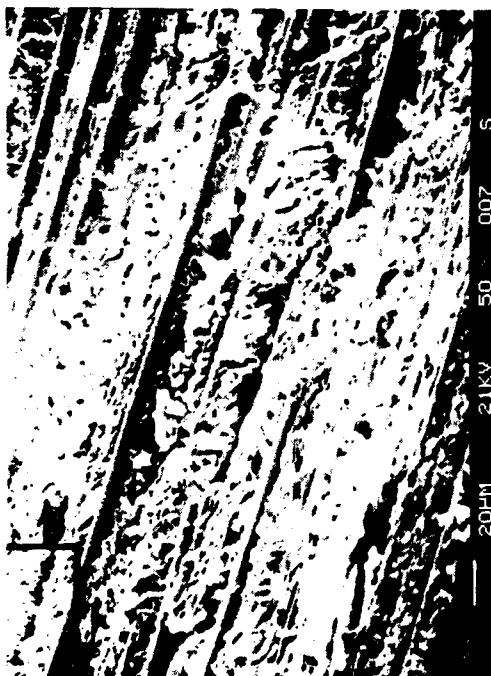
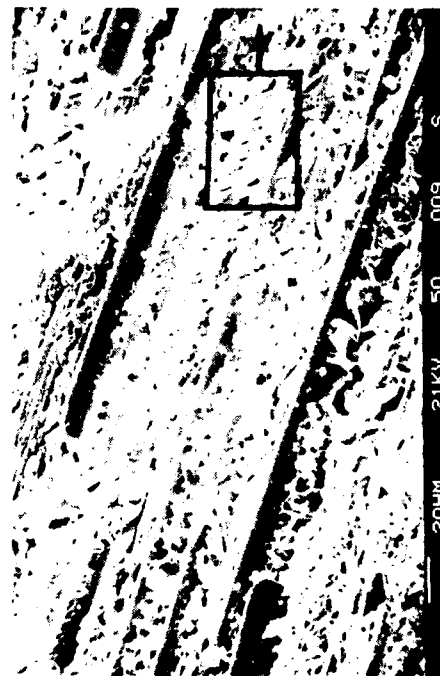
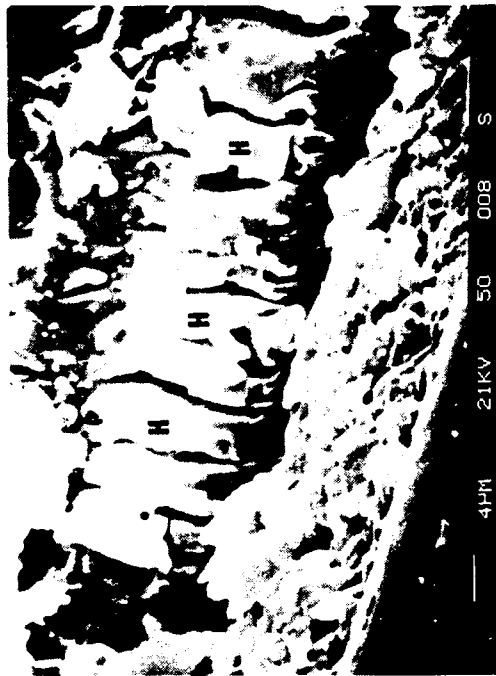
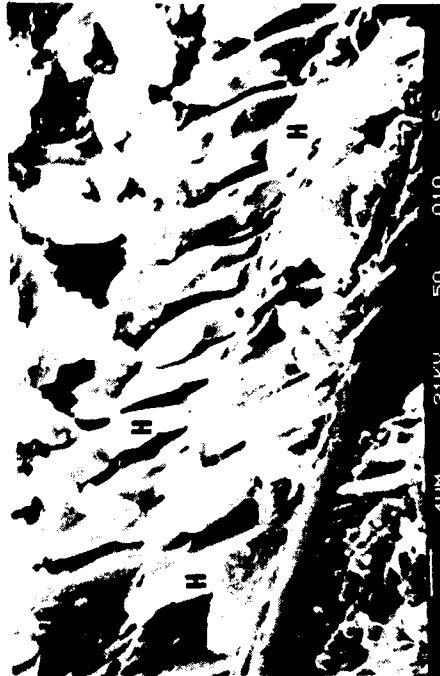
Delamination—50 degree tilt 400X

Figure 7.4-25. SEM Fractographs of Delamination Adjacent to Translaminar Fracture. Hackles indicate shear fracture and propagation of the delamination axially along the strut.

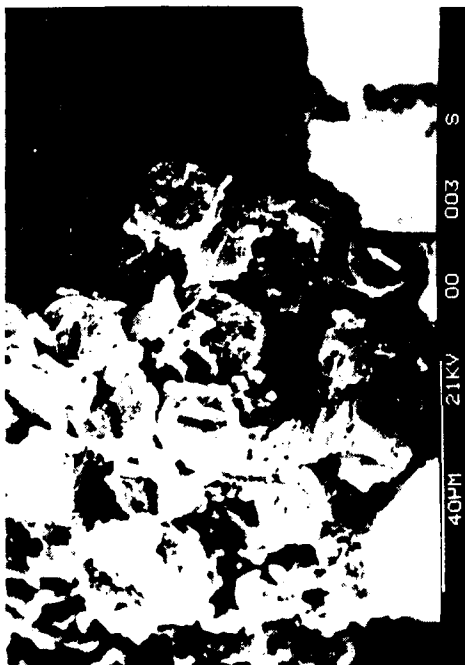
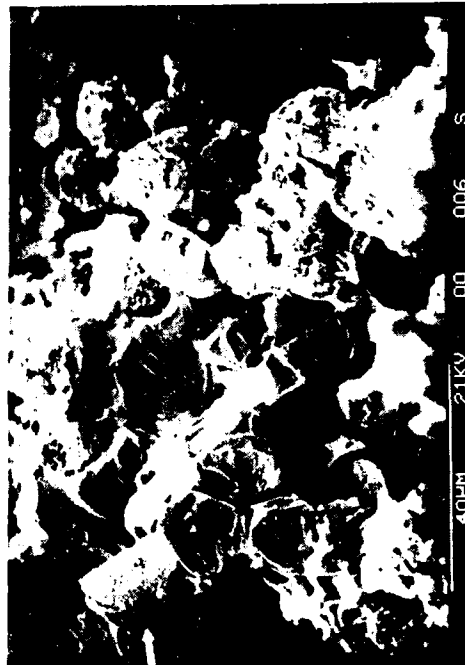
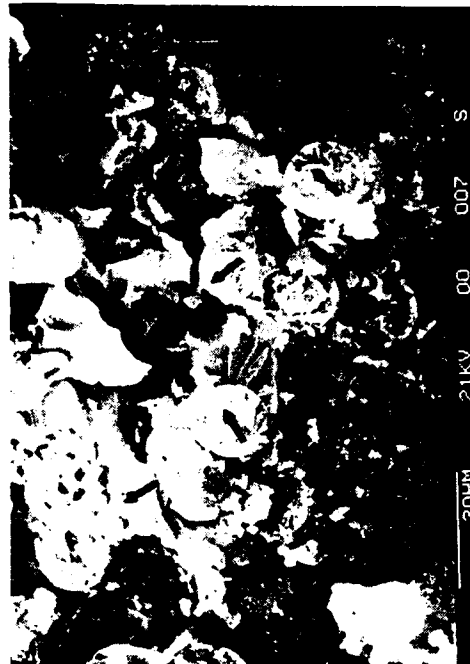
Tensile fracture—0 degree tilt 975X

Figure 7.4-26. SEM Fractographs of the Tensile Half of the Translaminar Fracture Surface. Small arrows show crack propagation direction indicated by individual fiber end fractures. The overall crack propagation direction indicated by these fibers is toward the delamination from the lower (tensile) surface.

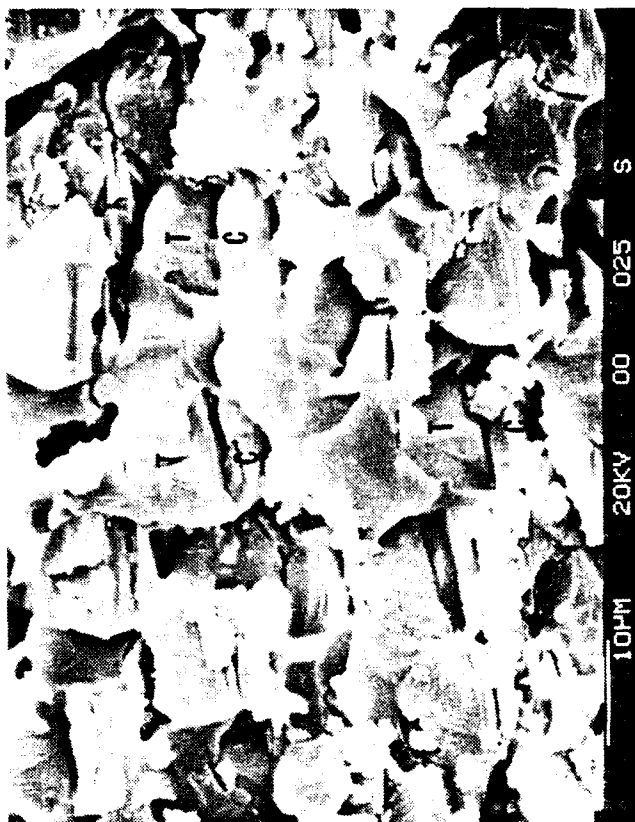
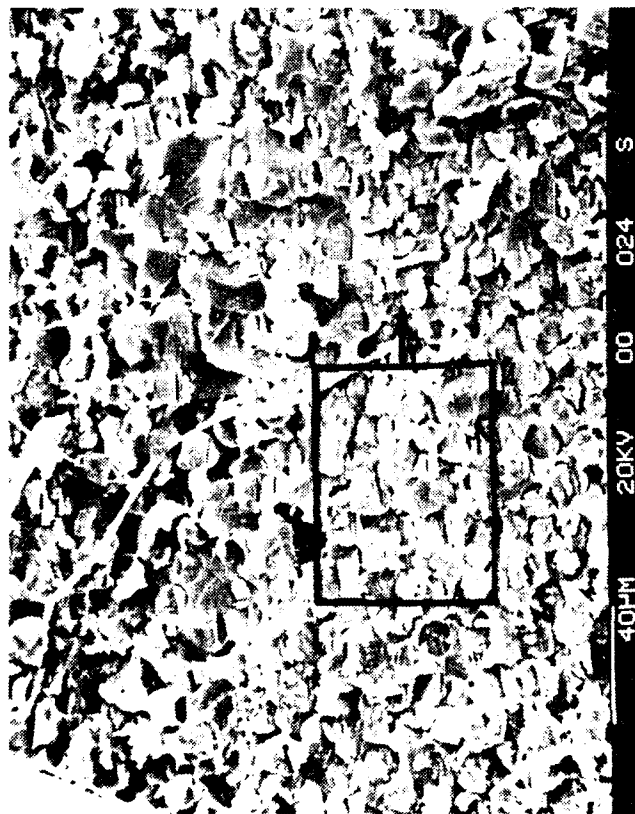
Compressive fracture—0 degree tilt

Figure 7.4-27. SEM Fractographs of the Compressive Half of the Translaminar Fracture. These fractographs exhibit compressively loaded fiber fractures, as indicated by the presence of both tensile and compressive fracture morphology

tensile fiber radial patterns indicated propagation from the tensile surface toward the delaminations and since the observed delaminations are discontinuous, it is inferred that initiation of the translaminar fracture occurred prior to delamination.

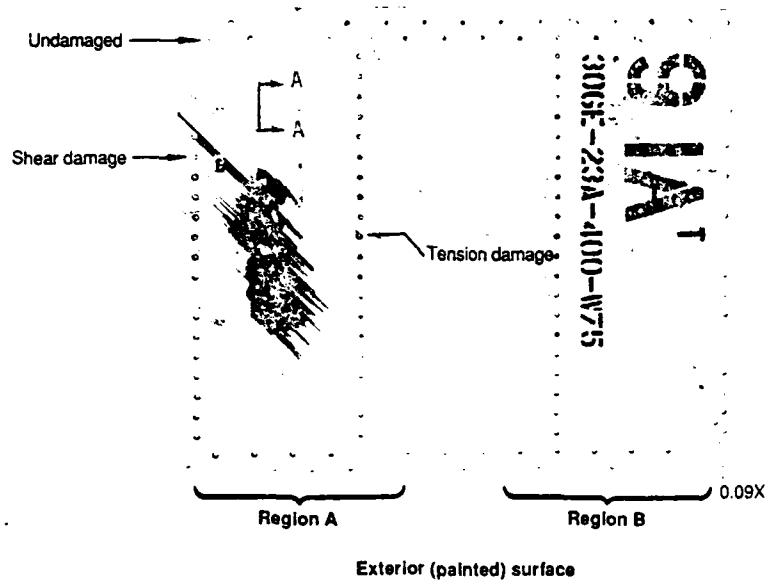
Interior (unpainted) surface

*Photomicrograph of the Component as Received*

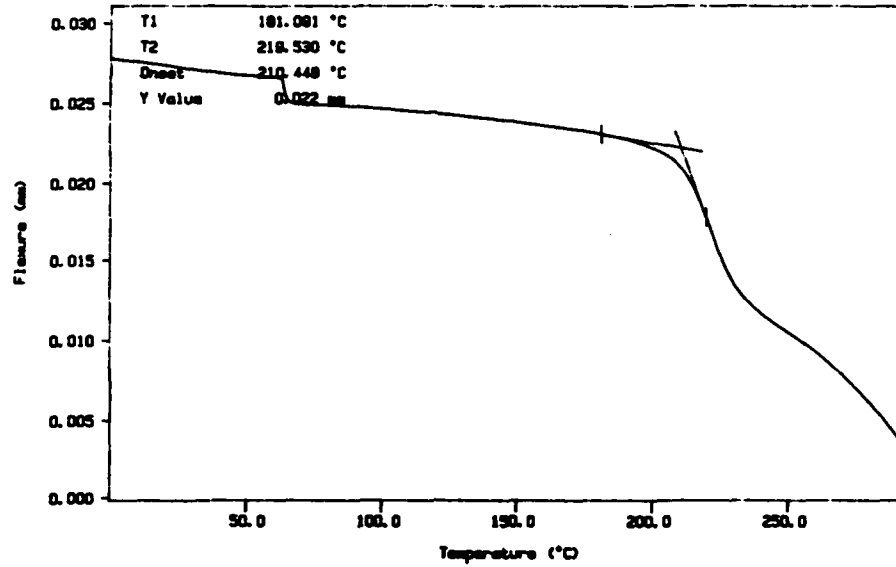
TMA of sample 1  $T_g = 210.448^\circ\text{C}$

TMA Thermograms Showing an Average Glass Transition Temperature of  $210^\circ\text{C}$

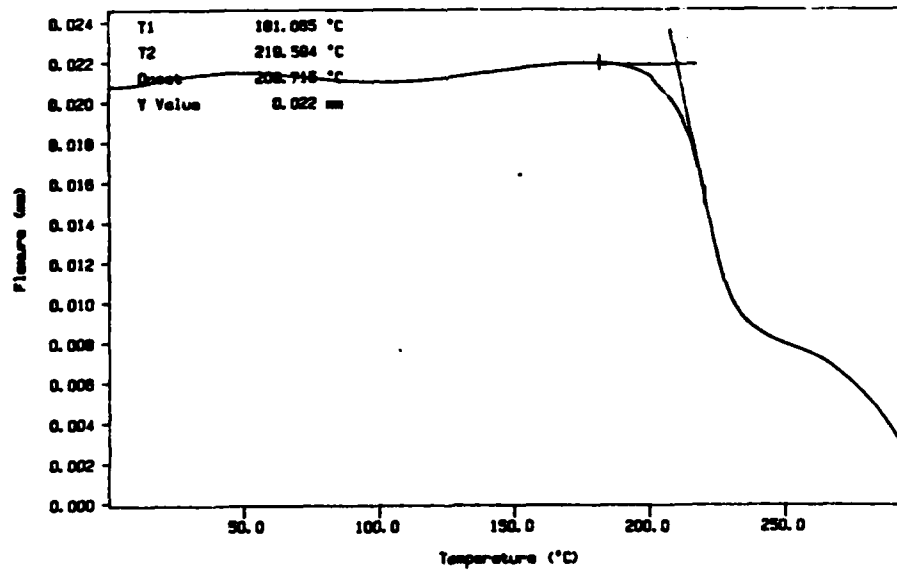
TMA of sample 2  $T_g = 208.715^\circ\text{C}$

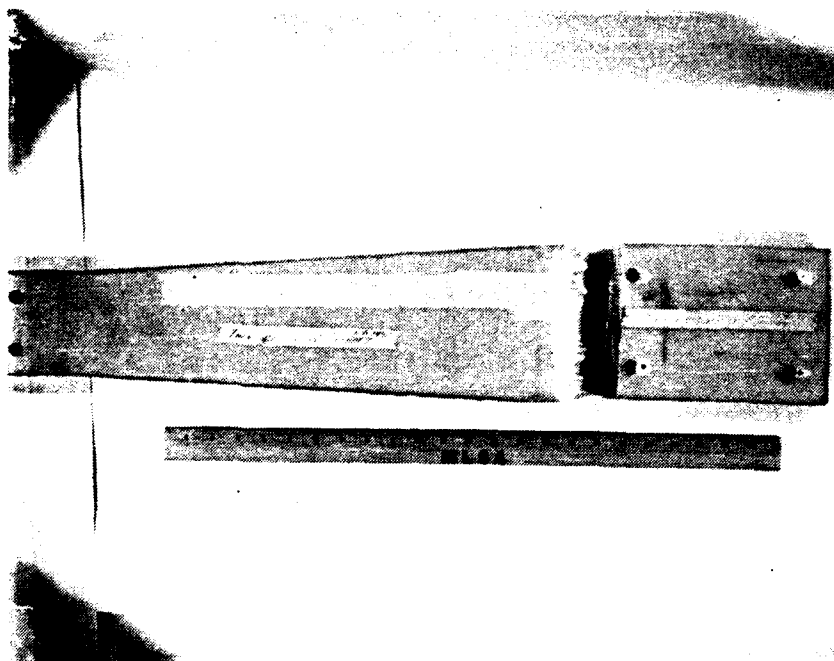
COMMENTS: Photomicrograph of the strut upper surface in the as-received condition.

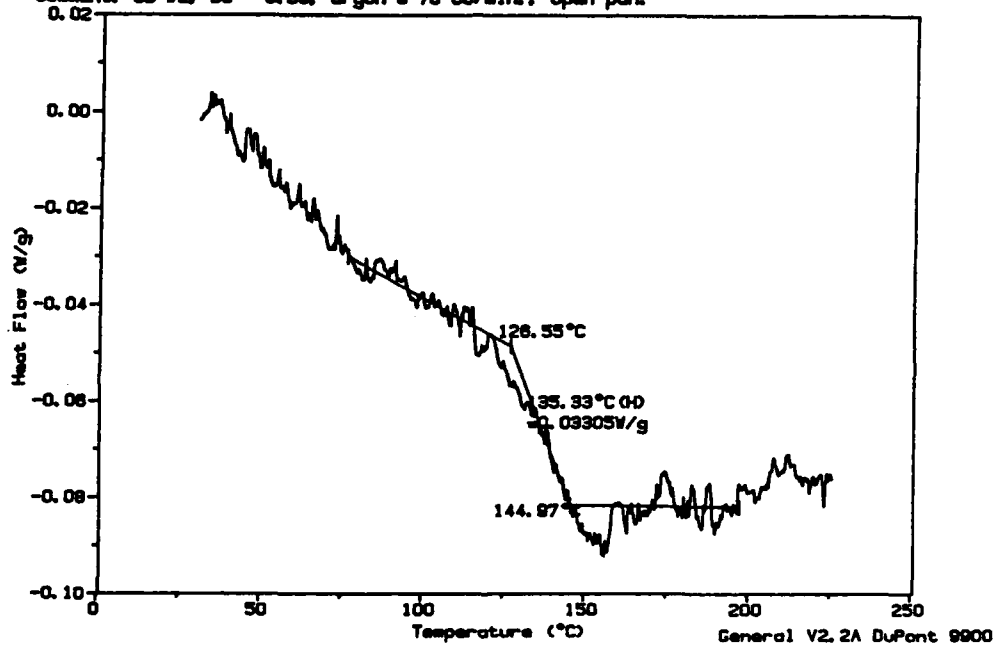
COMMENTS: Glass transition temperature was measured as 135°C by DSC.
